# PRE-DEMOLITION ENVIRONMENTAL INSPECTION SUMMARY REPORT

Ingham County Land Bank  
3024 Turner Street  
Lansing, MI 48906

Parcel:	33010116106061
House No:	510 N. Sycamore St., Lansing, MI 48933
Date Inspected:	August 1, 2015
Inspected By:	Forrest Budd
Inspectors State Card #	A-37627

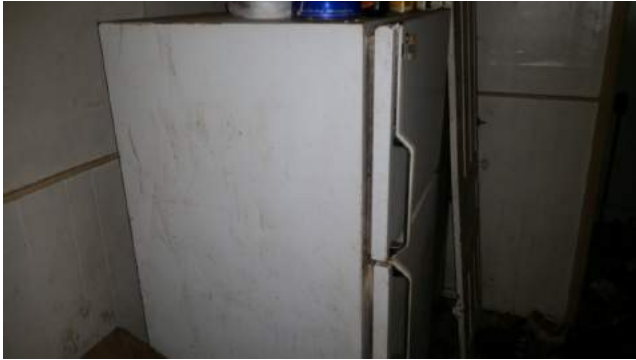
Refrigerator,  
Room 4

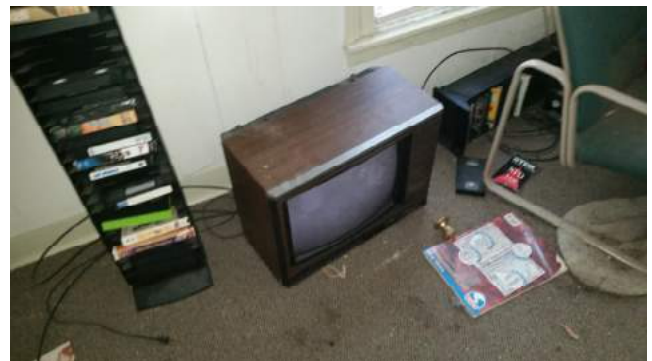
Television,  
Room 9

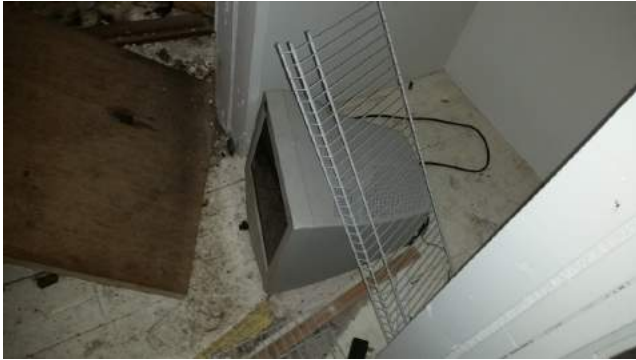
Computer Monitor,  
Room 25

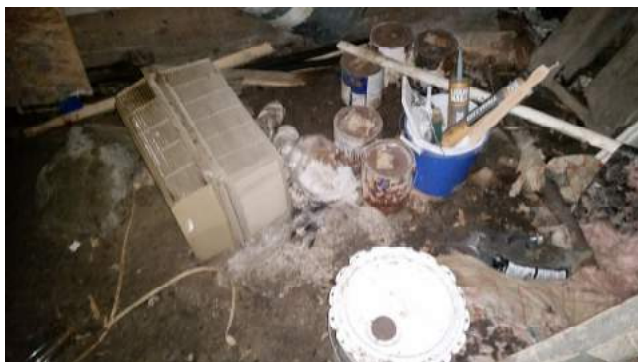
Air Conditioner: Unit or Whole House,  
Room 28

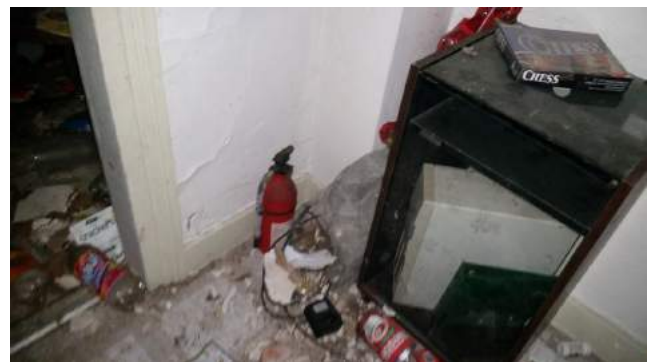
Fire Extinguisher,  
Room 8

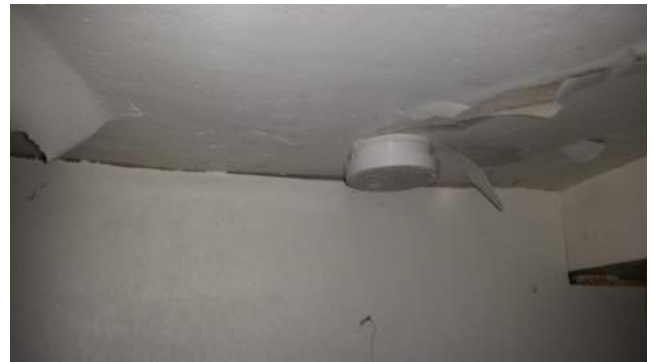
Smoke Detector,  
Room 15

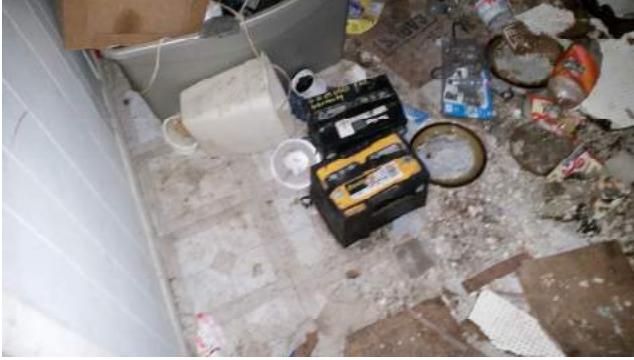
Vehicle Batteries,  
Room 7

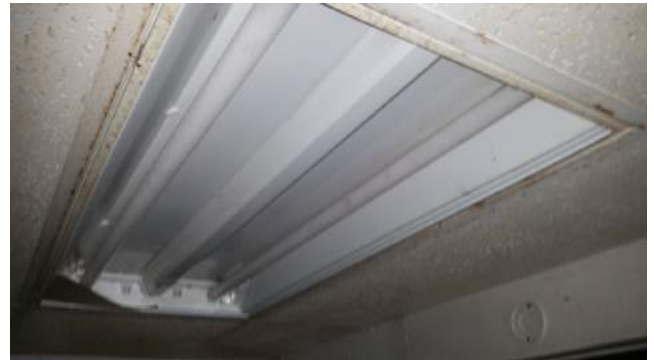
Ballasts,  
Room 8

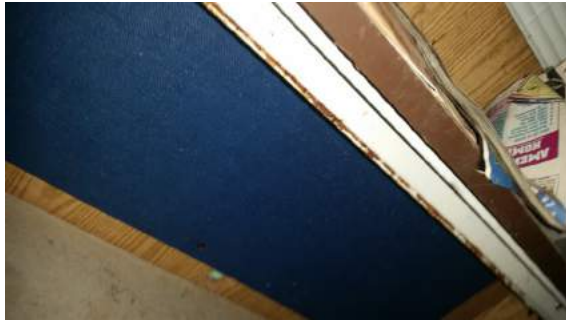
Ballasts,  
Room 2

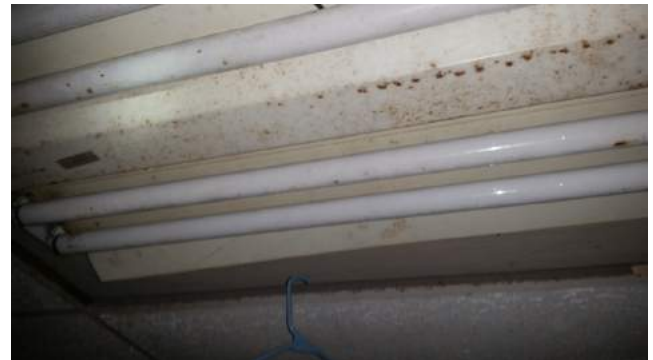
Fluorescent light tubes, greater than 4 ft,  
Room 3 & Room 27

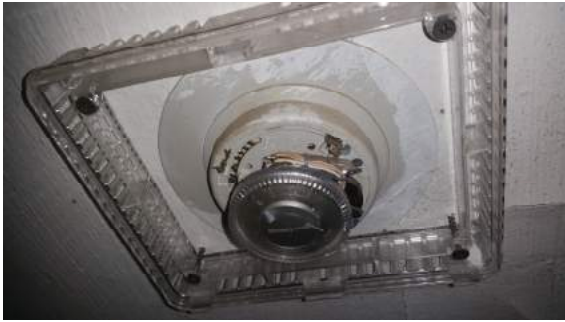
Mercury Thermostat,  
Room 1

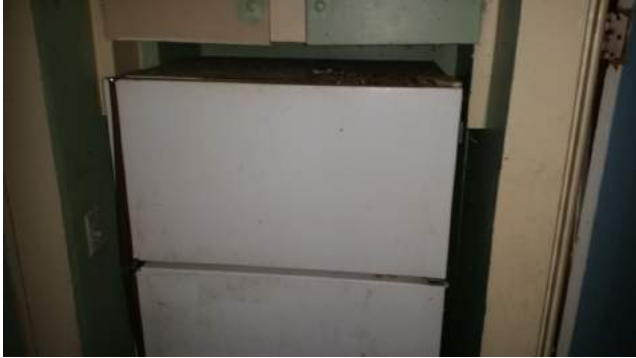
Refrigerator,  
Room 2

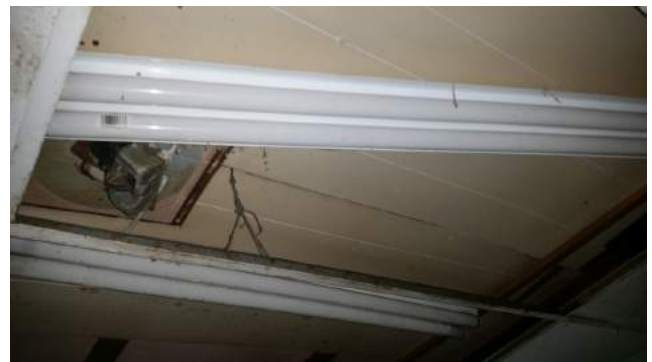
Ballasts,  
Fluorescent light tubes, 4ft or less,  
Room 2

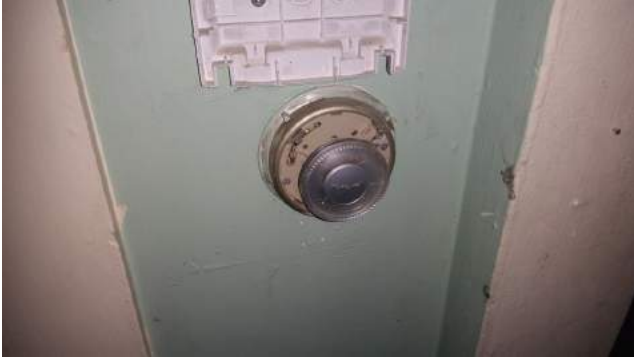
Mercury Thermostat,  
Room 2

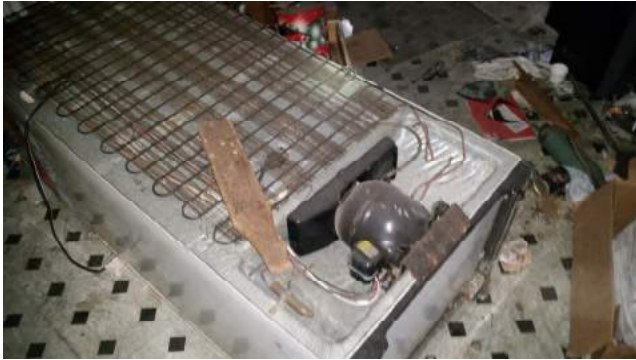
Refrigerator,  
Room 8

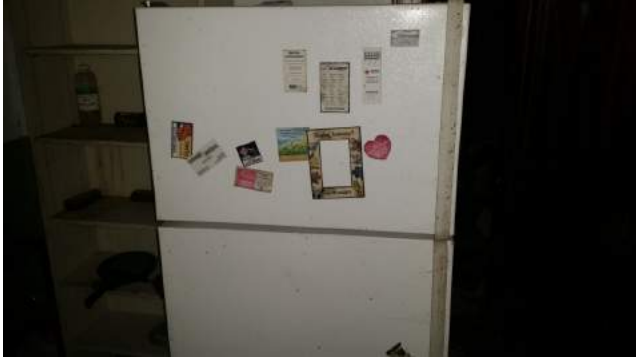
Refrigerator,  
Room 5

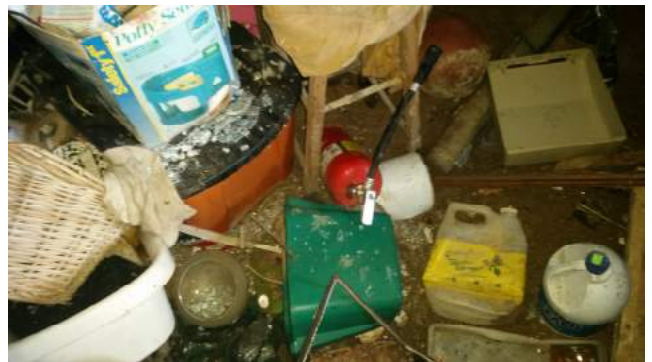
Fire Extinguisher,  
Room 10

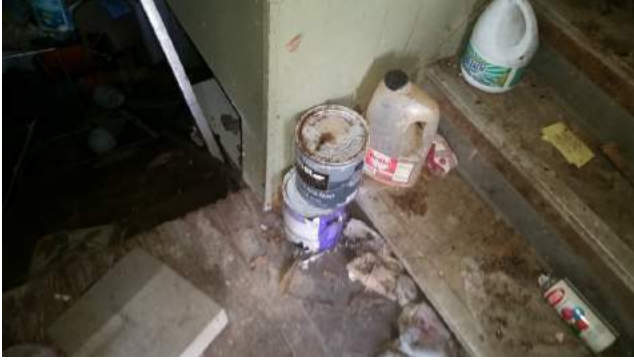
Paint Can (Latex),  
Room 6

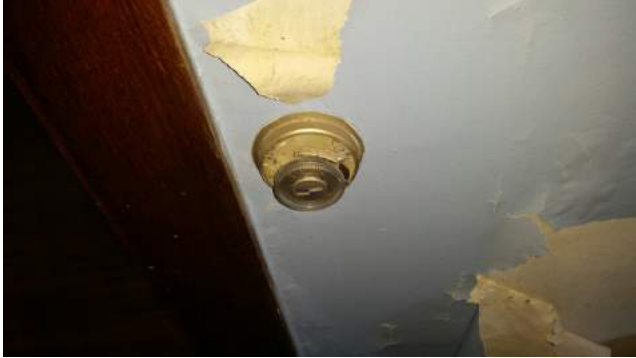
Mercury Thermostat,  
Room 1

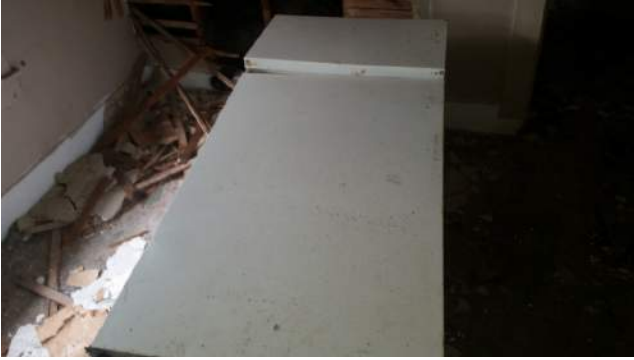
Refrigerator,  
Room 14

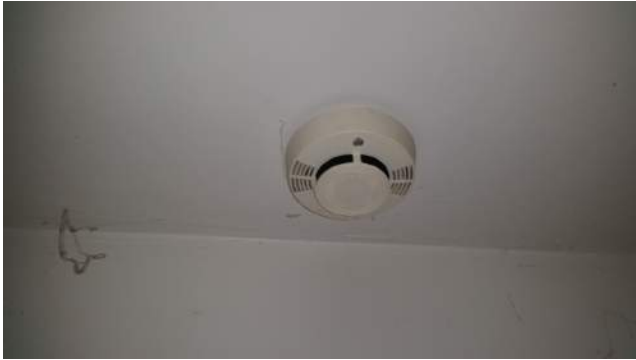
Smoke Detector,  
Room 8

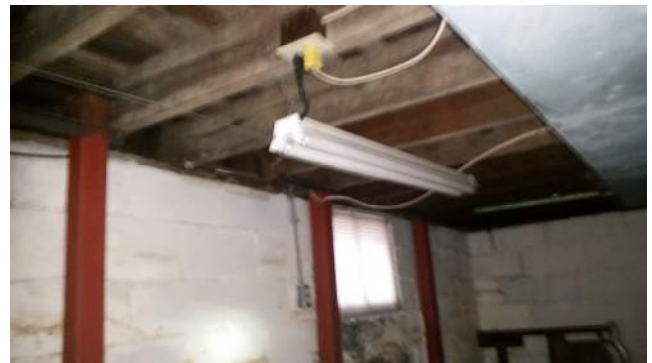
Ballasts,  
Fluorescent Light Tubes, 4ft or less,  
Room 11

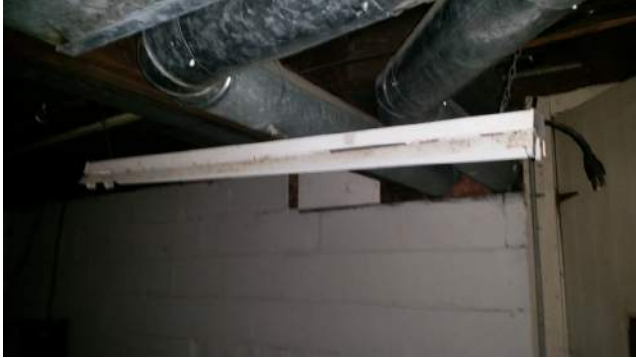
Ballasts,  
Room 10

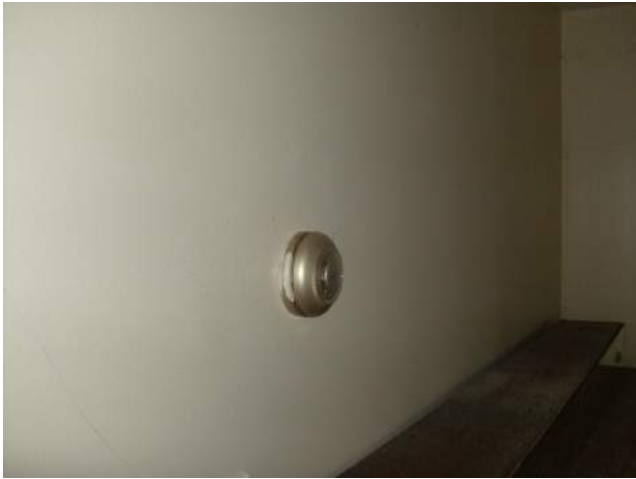
Mercury Thermostat– Living Room 1

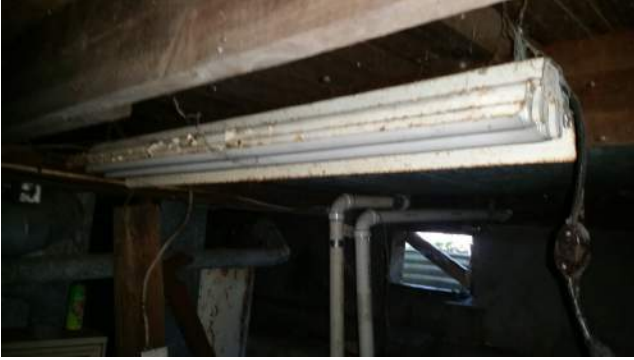
Ballast, Room 8
