# PRE-DEMOLITION ENVIRONMENTAL INSPECTION SUMMARY REPORT

Ingham County Land Bank  
3024 Turner Street  
Lansing, MI 48906

Parcel:	33010116106061
House No:	510 N. Sycamore St., Lansing, MI 48933
Date Inspected:	August 1, 2015
Inspected By:	Forrest Budd
Inspectors State Card #	A-37627

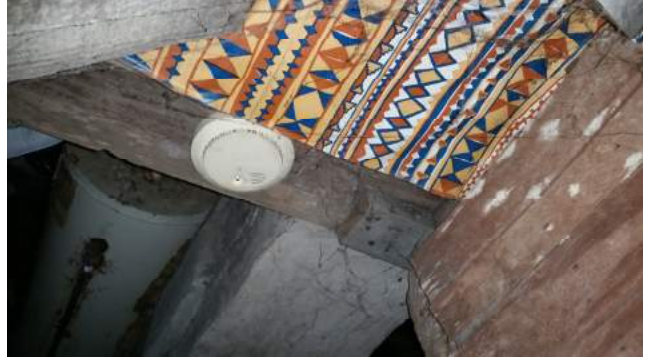
Smoke Detector,  
Room 10

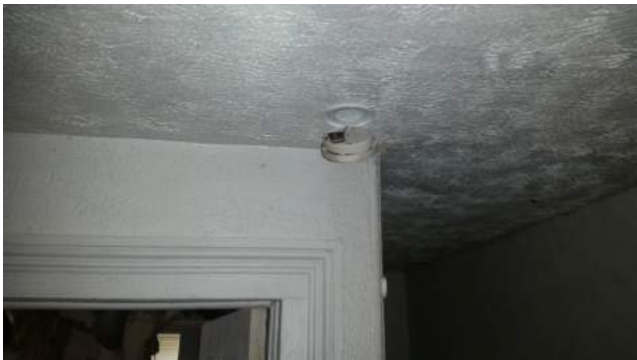
Smoke Detector,  
Room 24

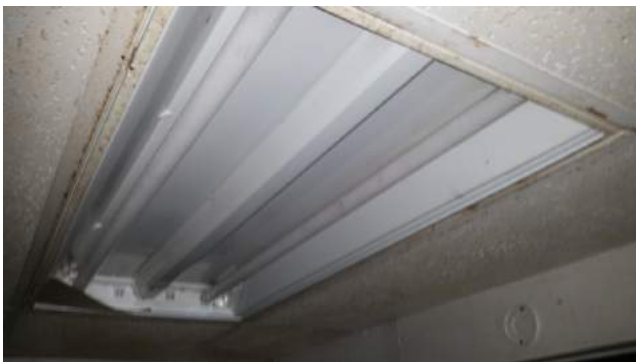
Fluorescent light tubes, greater than 4 ft,  
Room 2

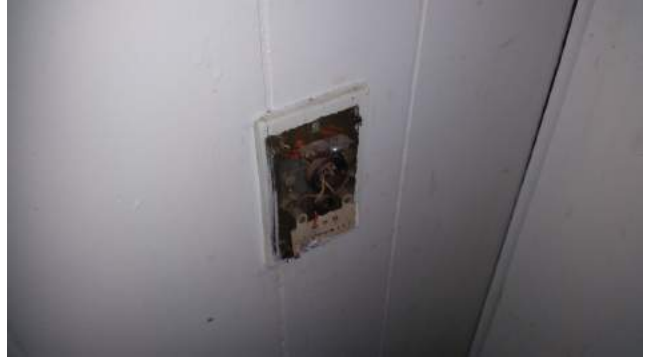
Mercury Thermostat,  
Room 8

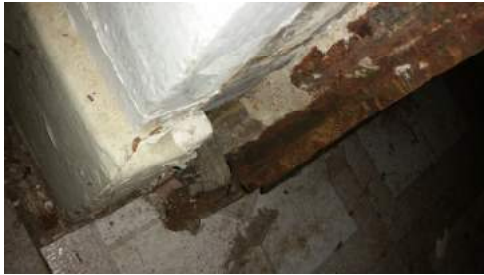
Duct Insulation,  
1st & 2nd Floor & Basement

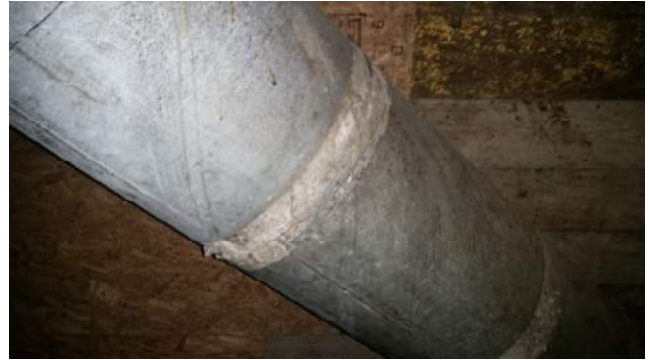
Duct Tape,  
Rooms 27 & 28

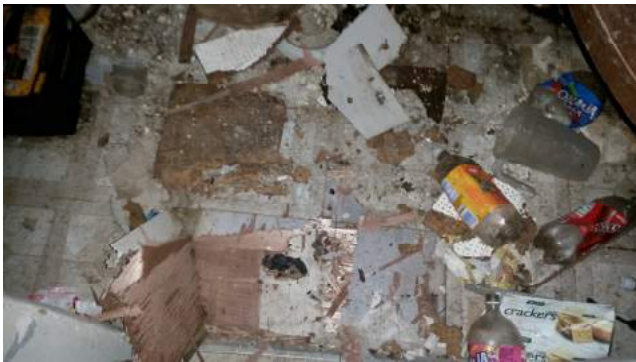
Floor Tile & Mastic,  
Room 7, 3rd

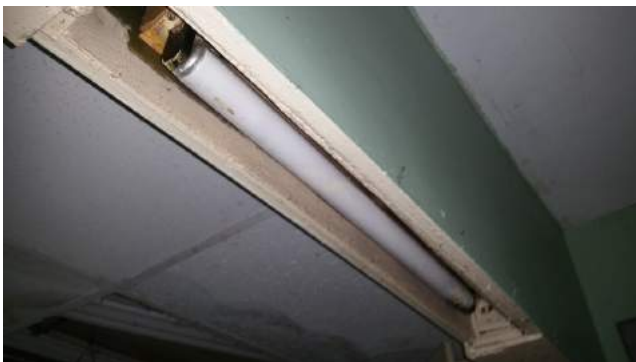
Ballasts,  
Fluorescent light tubes, 4ft or less,  
Room 2

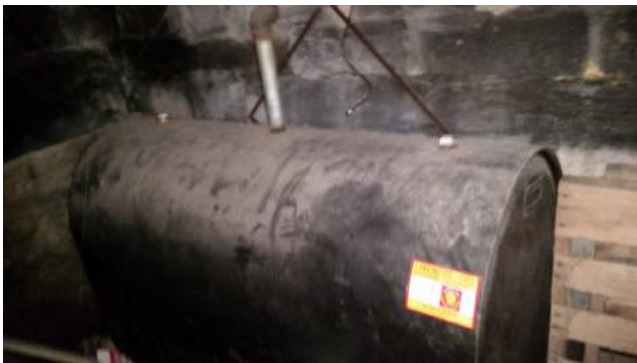
Above Ground Storage Tank: Appears  
Empty,  
Room 13

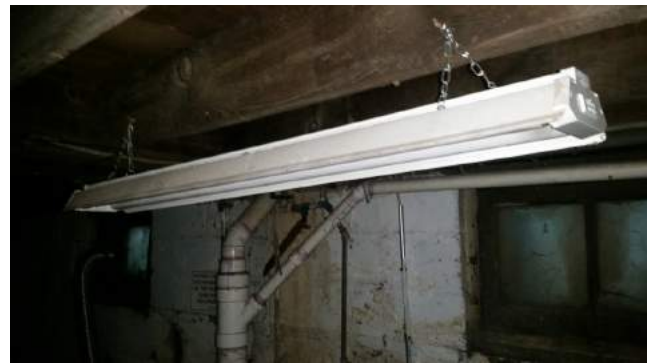
Ballasts,  
Fluorescent light tubes, 4ft or less,  
Room 12

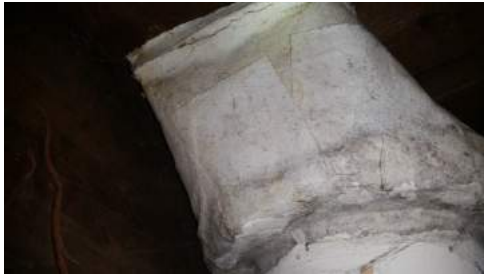
Duct Insulation,  
1st Floor & Basement  
3 Duct Runs to 2nd Floor

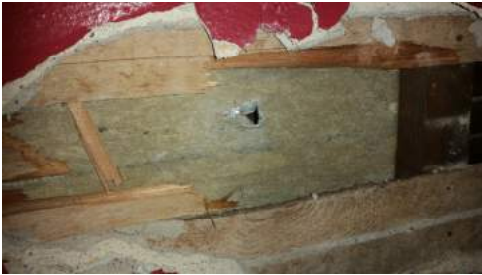
Duct Insulation,  
1st Floor & Basement,  
1 Duct Run to 2nd Floor

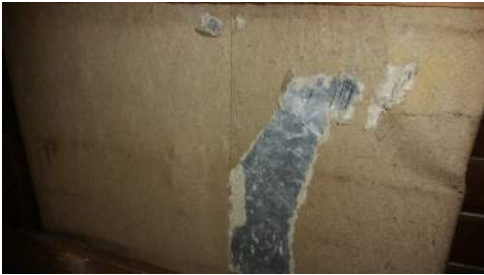
Duct Insulation,  
1st Floor, 3 Duct Runs

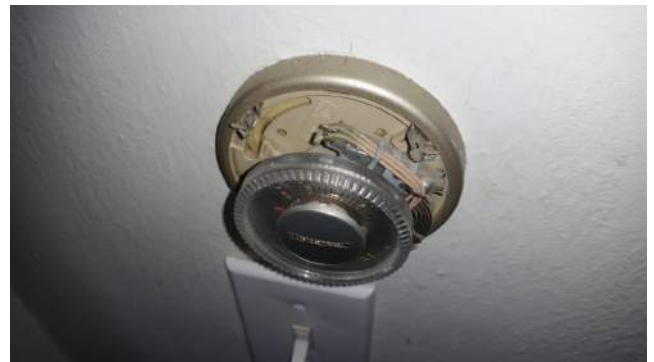
Mercury Thermostat,  
Room 8

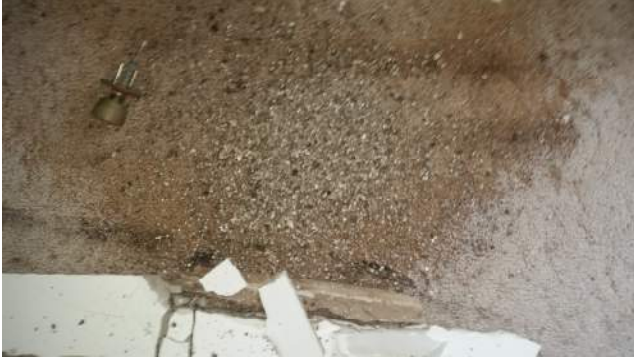
Vermiculite,  
1st Floor Ceiling

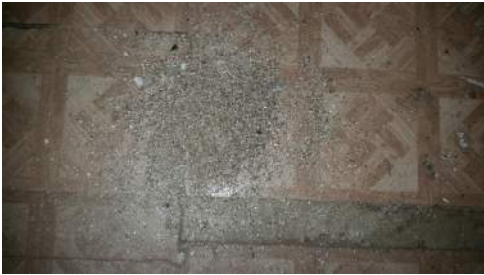
Vermiculite,  
1st Floor Ceiling
