# PRE-DEMOLITION ENVIRONMENTAL INSPECTION SUMMARY REPORT

Ingham County Land Bank  
3024 Turner Street  
Lansing, MI 48906

Parcel:	33010116106061
House No:	510 N. Sycamore St., Lansing, MI 48933
Date Inspected:	August 1, 2015
Inspected By:	Forrest Budd
Inspectors State Card #	A-37627

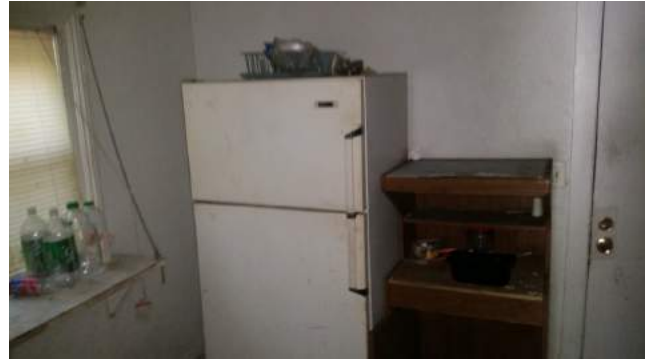
Refrigerator,  
Room 7

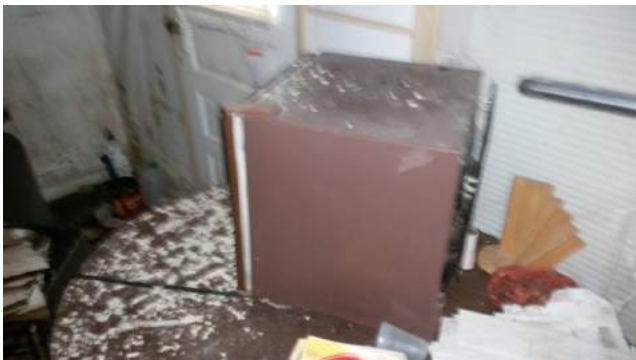
Refrigerator,  
Room 7

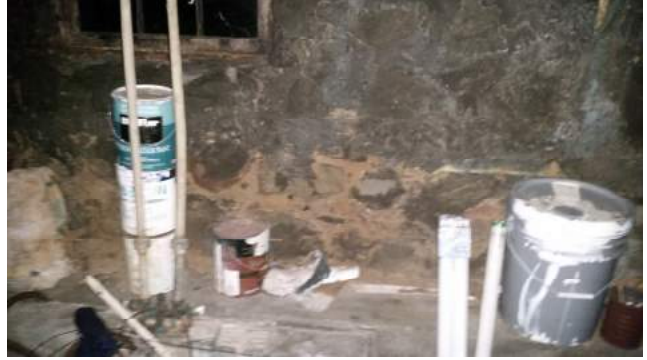
Paint Can (Latex),  
Room 27

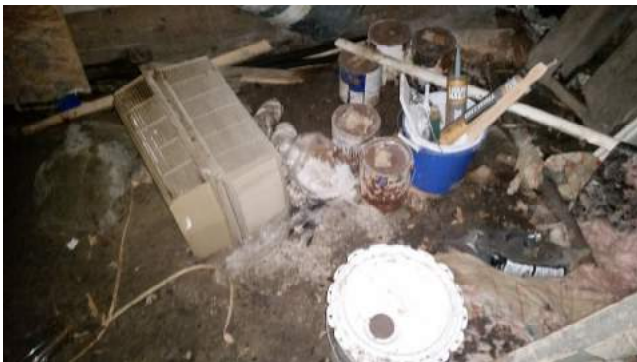
Paint Can (Latex),  
Room 28

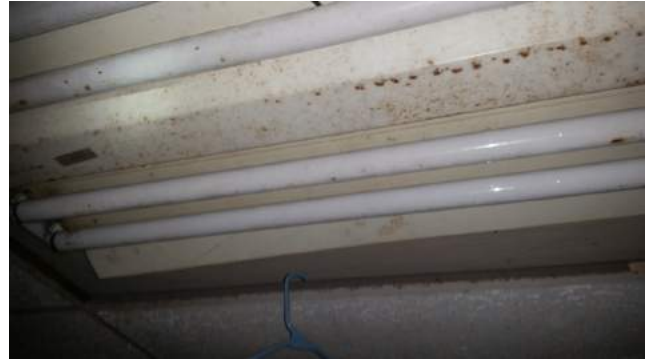
Ballasts,  
Room 3

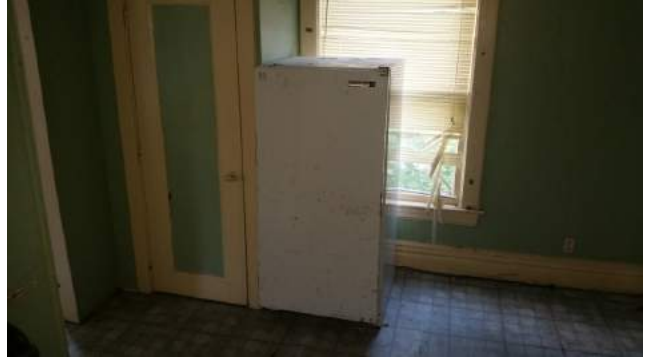
Refrigerator,  
Room 2

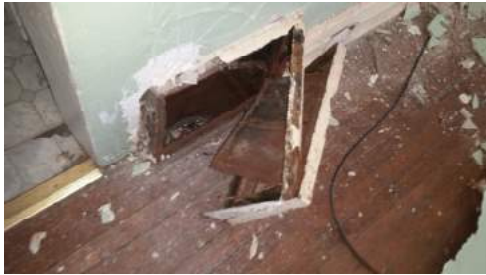
Duct Insulation, Grey, Rooms 1, 2, 8

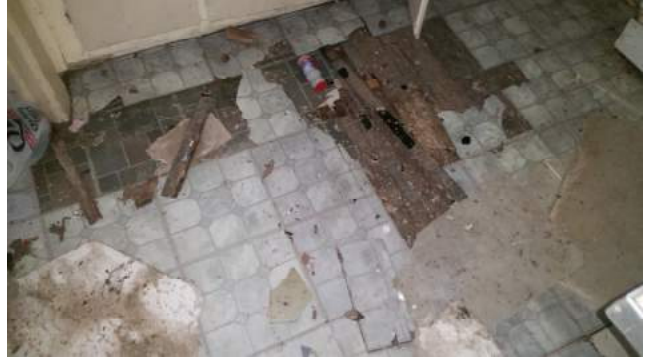
Floor Tile and Mastic, 9x9 Brown, Rooms 2, 4, 12, 3rd

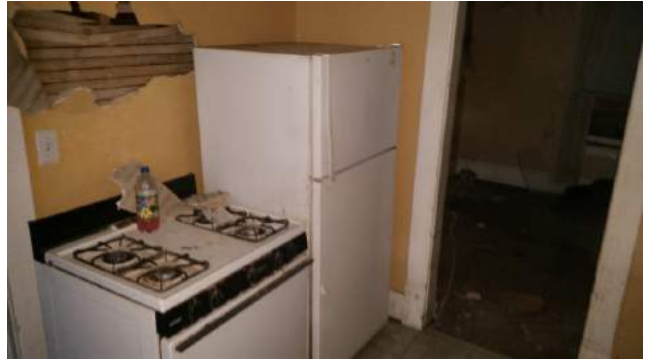
Refrigerator,  
Room 18

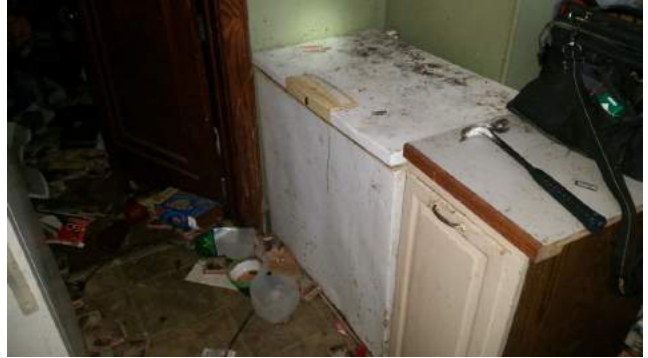
Freezer,  
Room 5

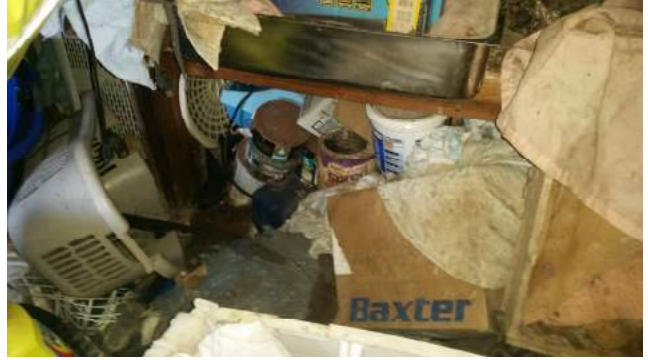
Paint Can (Latex),  
Room 10

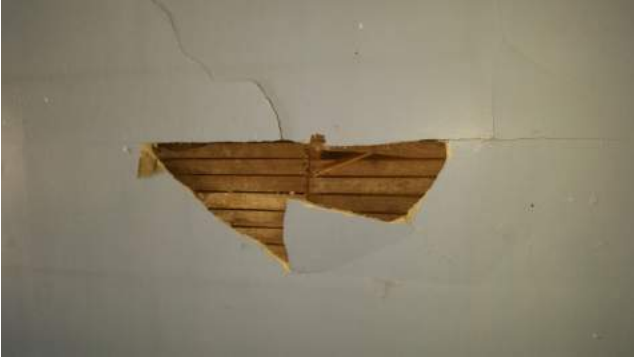
Plaster, Grey, Wood Lattice, 1st/2nd Floor

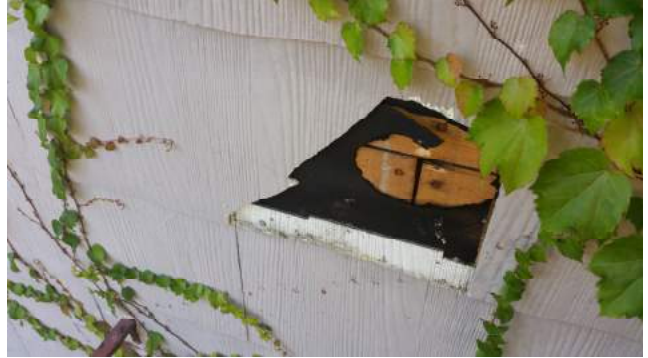
Transite Siding, Purple, Siding, 1st

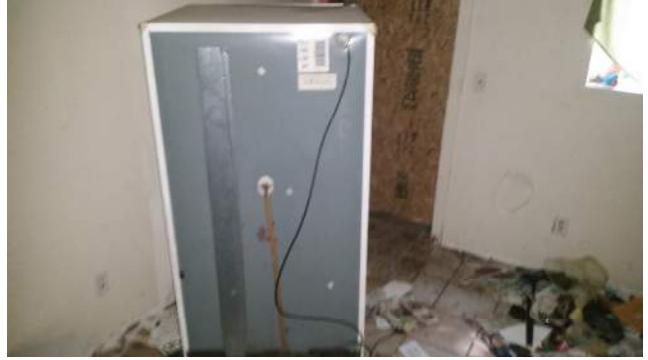
Freezer,  
Room 22

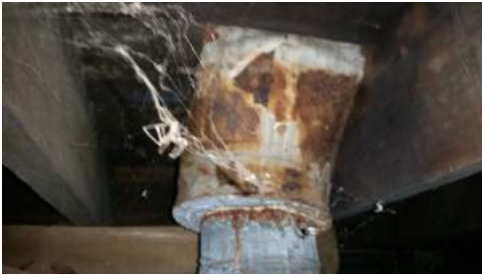
Duct Insulation, Grey, Room 7

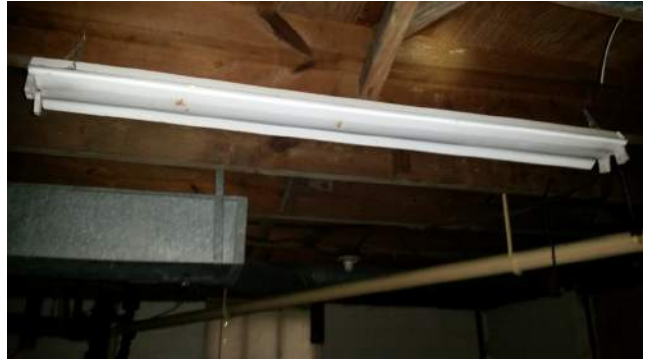
Ballasts,  
Room 3

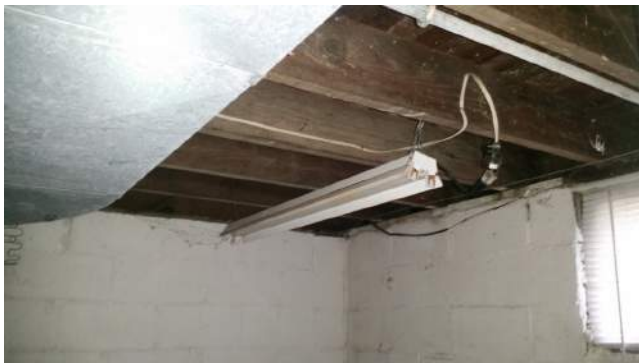
Ballasts,  
Room 9

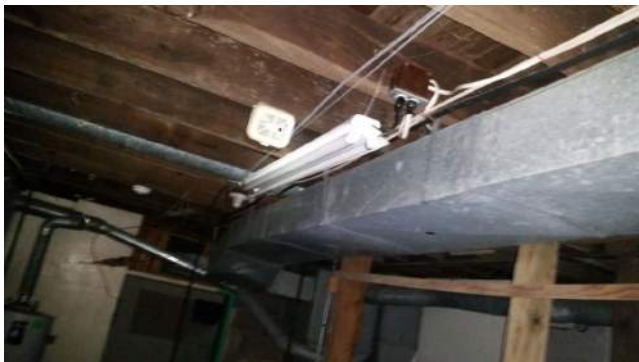
Fluorescent Light Tubes, 4ft or less,  
Room 4

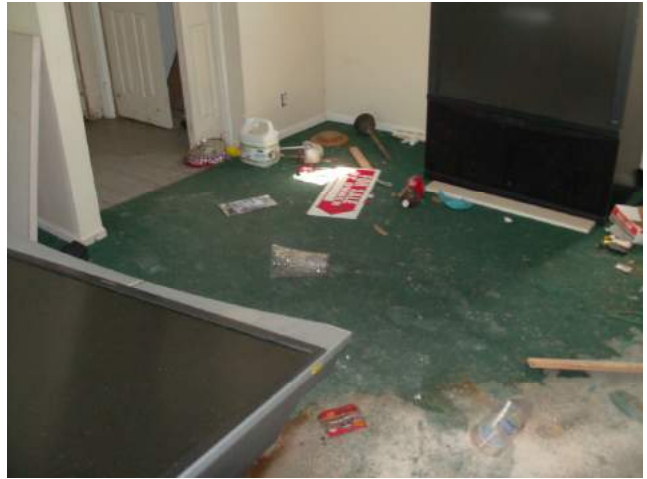
2 TV's– Living Room 1

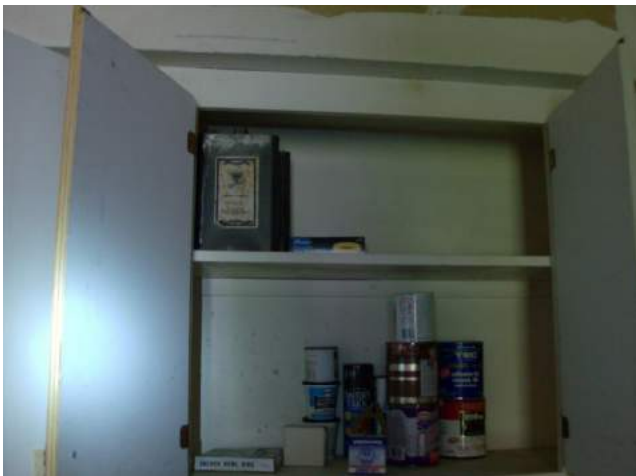
5 oz. Paint Cans and Lacquer Oil– Based Garage 9

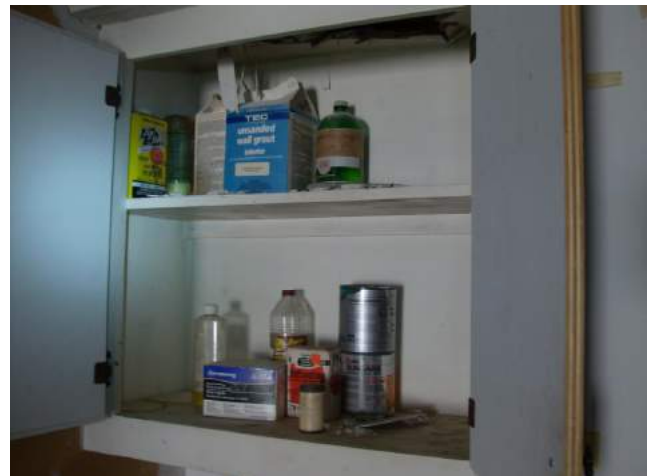
15 oz. Paint Thinner– Garage 9

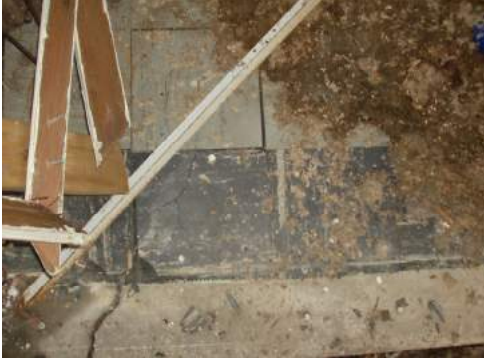
Floor Tile, 12x12 Grey and Black Checkered, Room 4

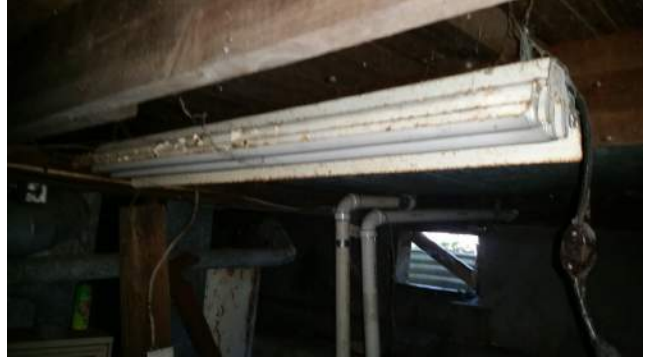
Halogen Bulb 4<, Room 8
